MEMO

File - Lone Star Cement Co.

Subject Complaint from Mike Patricelli

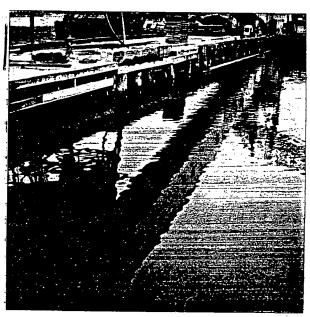
Photo # 3 2/24/82, 1010

After my initial observations, I spoke with Mr. Patricelli about the incident. He related that a sheen on the water, reminiscent of kerosene or paint thinner, accompanied the whitish discoloration. Because there had been no odor detected and there was no widespread "slick" when I arrived, I doubt if the oily sheen Mr. Patricelli observed was directly related to the milky substance. The oil was probably either at the outfall or present in the storm sewer in small, residual amounts before the whitish substance passed through the storm sewer. The spill was first noticed at about 0830 and had rapidly spread radially from the storm overflow. By the time I arrived, the line of the spill had almost reached Lone Star's pier line.

photo 1	view S.W. at Lone Star dock - 1000
photo 2	view S to area of storm outfall - 1000
photo 3	view W along Lone Star dock showing discoloration advancing toward, not from dock - 1010
photo 4	view N.W. showing line of discoloration advancing toward Lone Star dock - 1010
photo 5	soap suds immediately in front of storm outfall structure - 1050

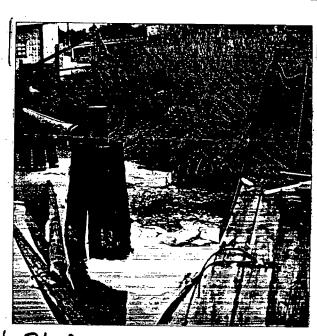
Photo #5 2/24/82, 1050

Following my interview with Mr. Patricelli, I walked and drove around the area drained by this storm sewer system. Main storm lines run down Ward St. and Minor Ave. N., join on the east of Fairview Ave. N. and run north into a outfall structure at the head of Waterway #6. The only significant observation was of a mobile wash company cleaning trucks in the south loading dock area of the Van de Kamp bakery (823 Yale Ave. N.). I questioned an employee of Ballou's Mobile Wash (Division of Olympic Cleaners, 228-0946) who was cleaning the Van de Kamp truck; he claimed to have only entered the area at about 1000 and begun operations at 1015. No further suspect areas were observed; all other catchbasins in tributary drains were dry and showed no signs of recent use. Before leaving the area, I again checked the storm overflow. A large quantity of soap suds was floating near the outfall structure. I assume these suds were resultant from the mobile wash operation at the Van de Kamp bakery. KMETRO

The source of this particular incident remains unknown. Time allowing, the storm sewer system should be identified to all sources. The possibility exists that an illegal, interior connection to the storm sewer has been made and is occasionally used for industrial discharges. The substance observed was not noticeablyirritable to wildlife; ducks and gulls were normally active foraging in the midst of the discoloration.
